Wave Measurements at the Pensacola Wave-Attenuation-Device Site

Ping Wang, Ph.D.
Department of Geology
University of South Florida

Loland Broussard
National Resources Conservation Service
646 Cajundome Blvd
Suite 180 Lafayette, LA 70506

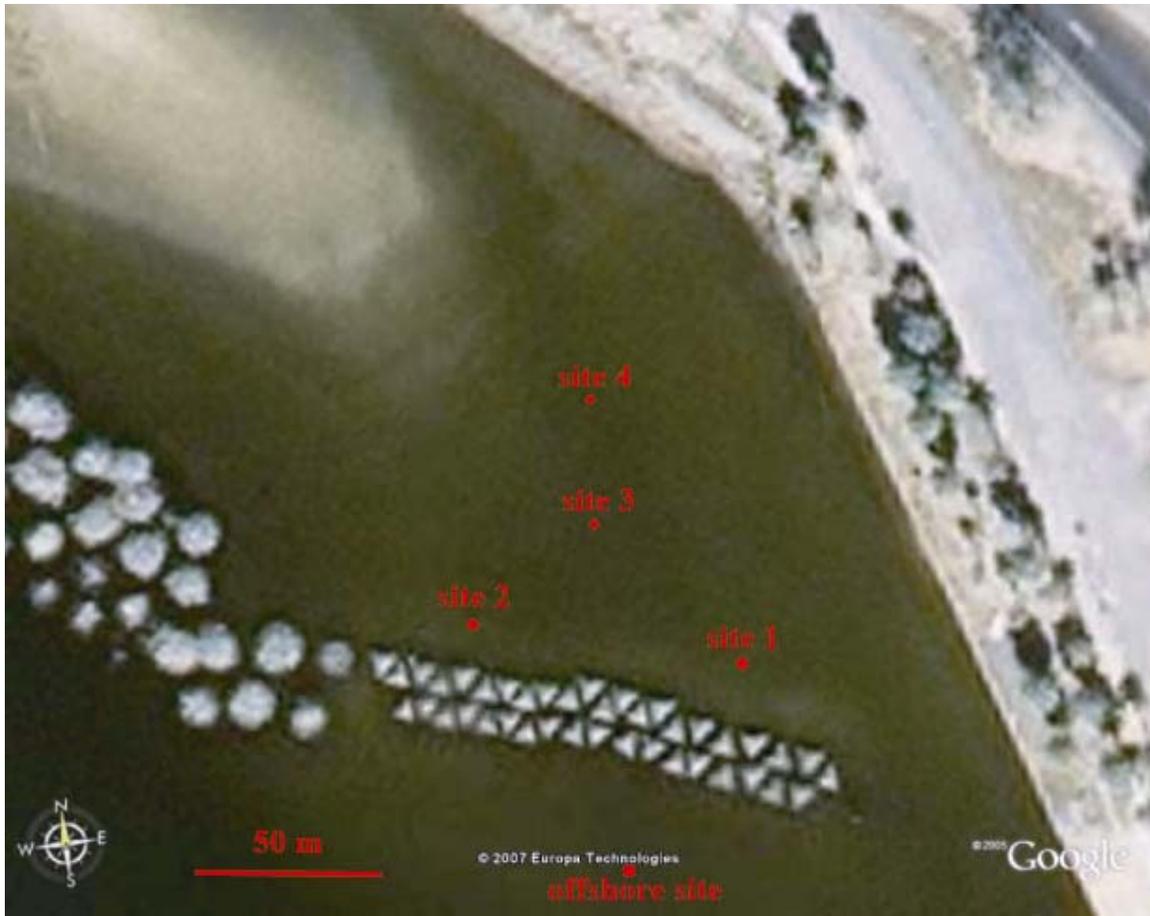
Figure 2. Aerial view of the study site and locations of the wave measurements.

The wave measurements were conducted at five different locations, including one offshore site and four sites in the protected area (Figure 2). The offshore site is roughly

30 m seaward of the structures with a water depth of 1.5 m. Site 1 in the protected area was selected to be close to the gap between the structures and the vertical seawall along the bridge, with a water depth of 1.4 m. The purpose of site 1 is to quantify the influences of wave transmission through the gap. Field observations also indicated considerable wave reflection from the vertical seawall. Wave conditions at site 1 are also influenced by the reflected waves. Site 2 is located near the western end of the structures. Based on field observation, limited wave energy was transmitted through the narrow gap between the CRI wave attenuation devices and the rubble mound breakwaters. Also, site 2 is relatively far from the seawall and should have a significantly reduced influence as compared to site 1. Site 3 is approximately one half of the length of the CRI structure landward. Site 4 is approximately one length of the CRI structure landward. The goal of sites 3 and 4 is to examine the extent of the wave sheltering by the CRI structures. It is worth noting that the wave attenuation devices and the rubble mound structures form a nearly continuous array of structure. The protected area is different from typical segmented breakwaters.

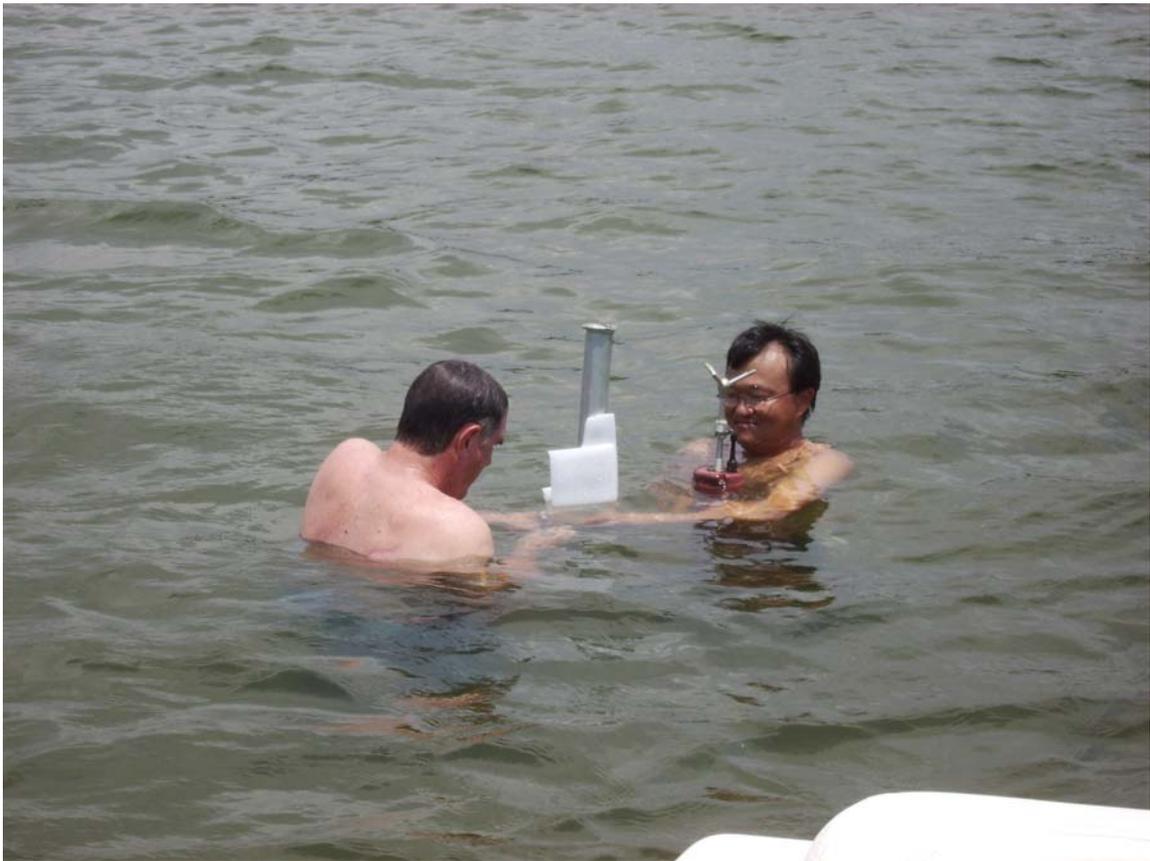
Figure 3. Installation of the Triton wave gage at Site 1.

for comparison. One wave gage was used to measure the wave conditions in the protected area (referred to as the nearshore gage in the following). This gage was moved from site 1 through site 4. The wave gages were mounted on a stable steel pipe which was pounded into the substrate (Figure 3).

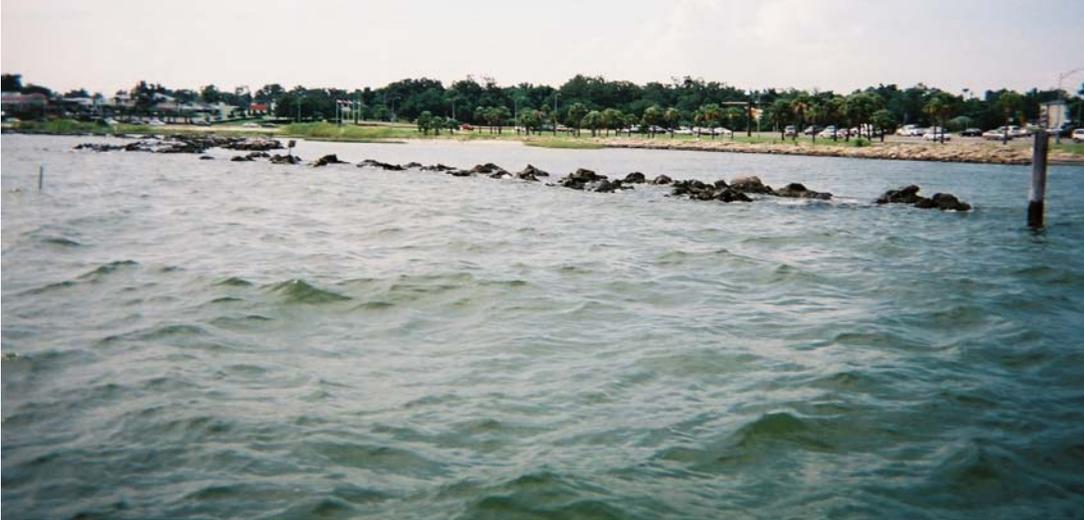
Figure 4. Visual comparison of the wave conditions seaward and landward of the structure.

Wave height and energy reduction caused by the wave attenuation device is apparent from visual observation (Figure 4). Much calmer water is observed landward of the structure. Considerable amount of wave energy entered the protected area from the gap between the structure and the seawall (Figure 5). In addition, waves reflected from the seawall are also visible in Figure 5. The reflected waves tend to be somewhat better organized than the choppy wind waves.

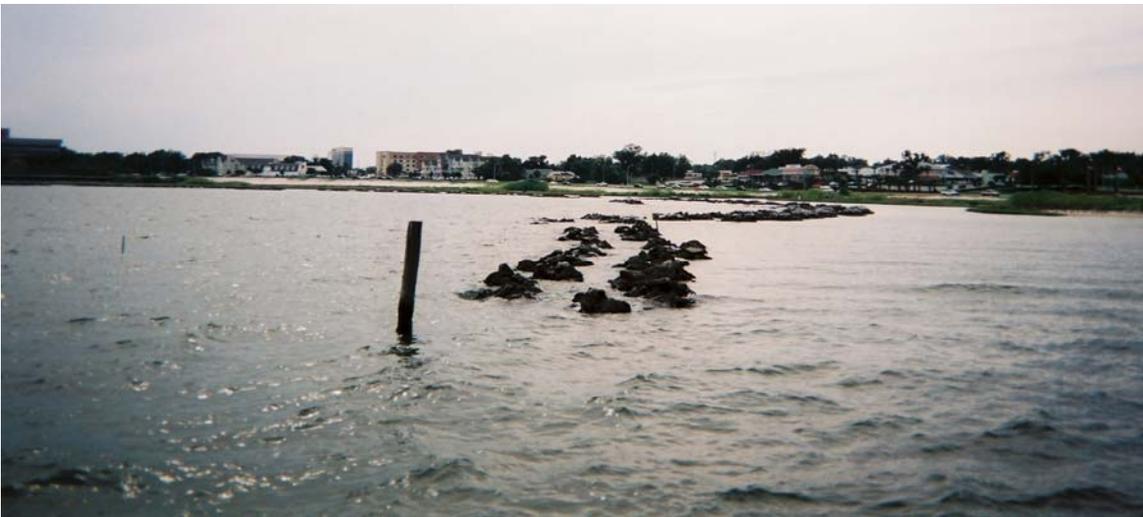
Figure 5. Wave propagation through the gap between the structure and the seawall (below the bottom of the picture). Note the reflected waves propagating nearly parallel to the structure.

Significant wave height reduction was measured at all the sites, although sites 2, 3, and 4 showed much greater reduction than site 1. Site 1 is influenced by the wave transmission through the gap between the seawall and the structures, and the reflected waves from the vertical seawall (Figure 5). Figures 6 through 9 illustrate examples of raw wave data collected at the offshore control site and the various sites in the protected zone. The wave height reduction can be observed directly from these figures.

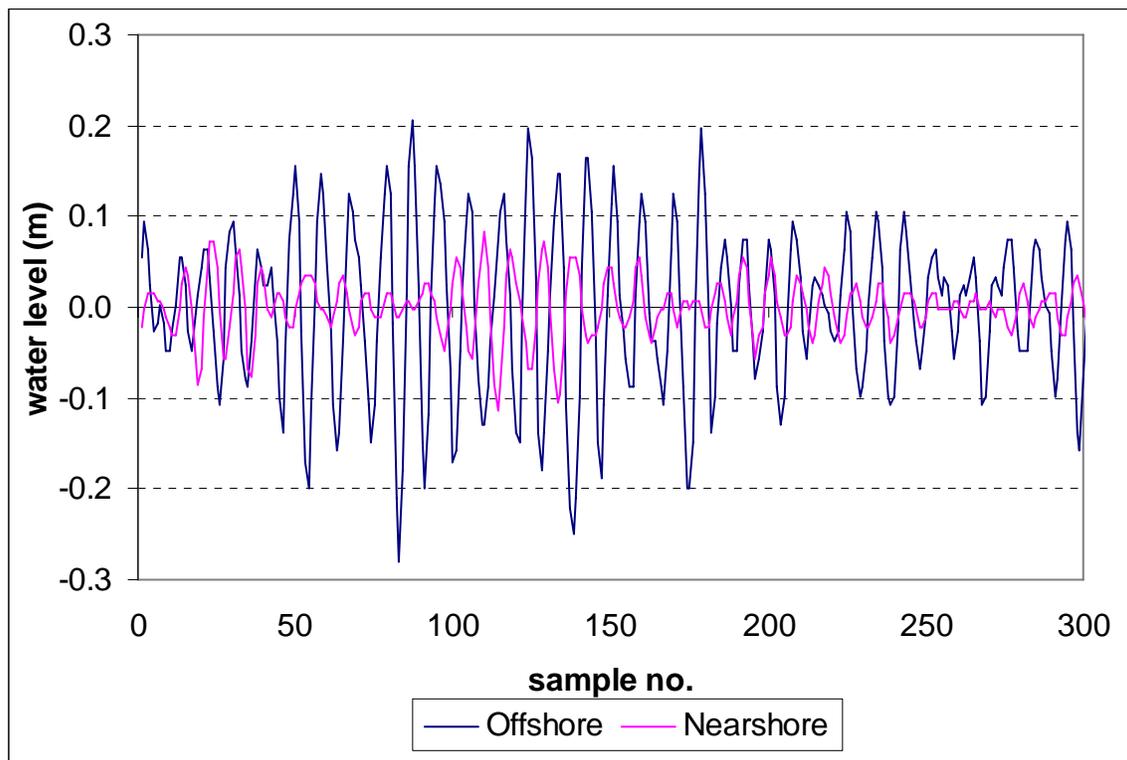
Figure 6. A portion of water level records comparing the offshore condition and condition at site 1, at 14:00 hours.

At site 1, waves with considerable heights, as compared to the offshore condition, were measured (Figure 6). The relatively well-organized higher waves are those

reflected from the seawall. Due to the specific location of site 1, i.e., near the gap and the seawall, this site may not provide a typical case for well protected areas. Some wave height variations were measured during the entire experiment. Figure 6 represented the highest offshore waves measured during the entire afternoon.

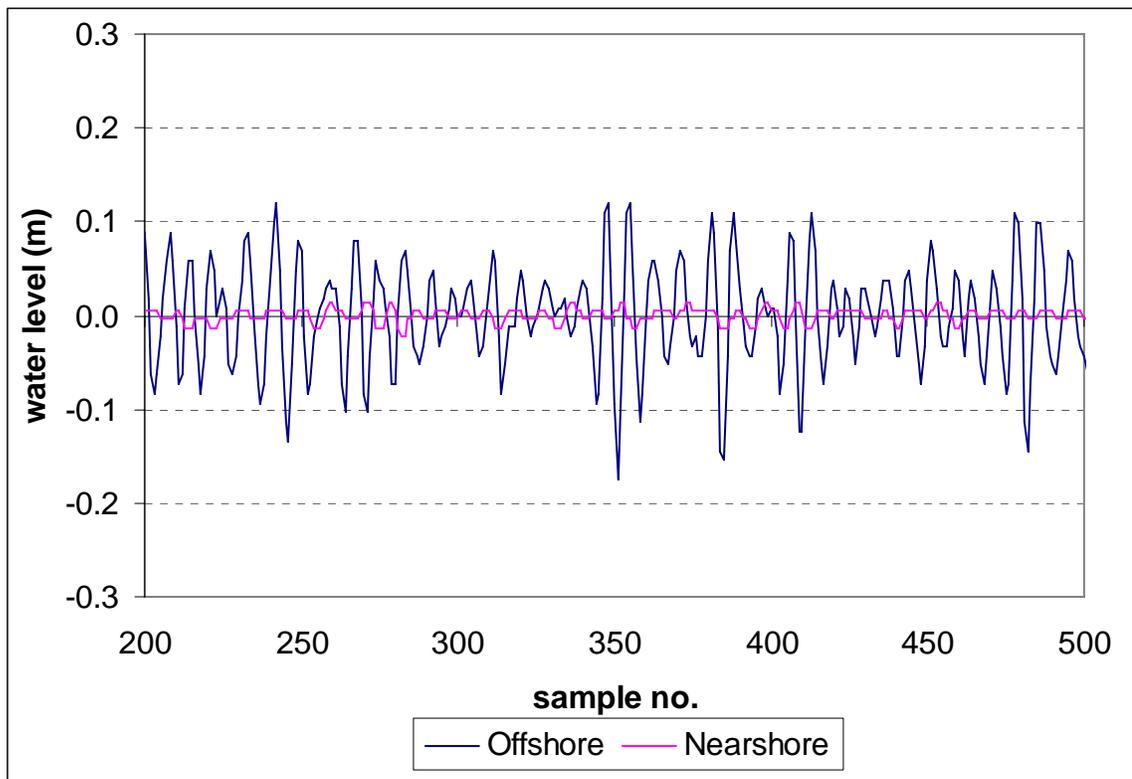
Figure 7. A portion of water level records comparing the offshore condition and condition at site 2, at 15:20.

At site 2 location near the western end of the wave attenuation device, much smaller waves were measured, as compared to the waves at site 1. The much greater wave reduction resulted from a combination of 1) minimal wave transmission through the very small gap between the wave attenuation device and the rubble mound structures, and 2) substantial dissipation of the reflected waves from the seawall. The data from site 2 also

indicate that although there are gaps between individual blocks of the CRI wave attenuation device, little wave energy transmits through the small gaps.

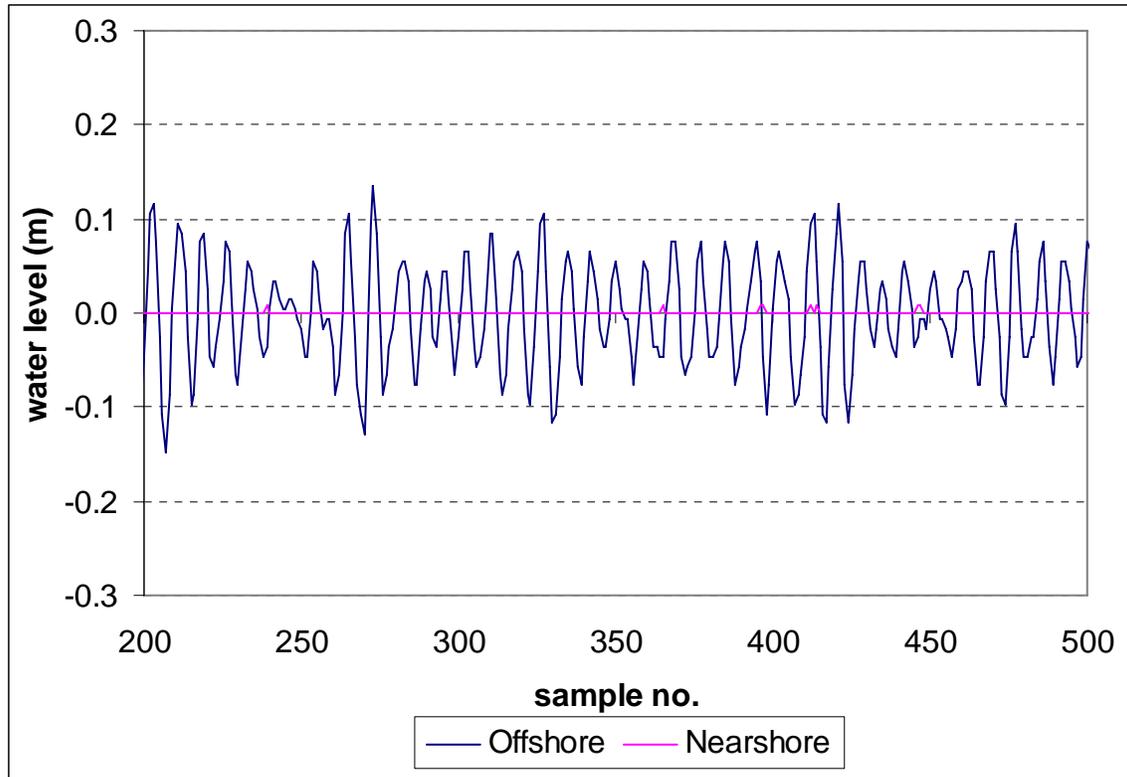
Figure 8. A portion of water level records comparing the offshore condition and condition at site 3, at 16:30.

Sites 3 and 4 located at a half and one structure length landward of the structure. Nearly no waves were measured at these two sites (Figures 8 and 9). Small wind ripples with wave length on the order of 0.3 m were observed in the field. However, these very high frequency wind ripples cannot be measured by the present wave gages. The energy contribution of these small wind ripples should be minimal. The nearly complete wave energy reduction as these two sites were also influenced by the specific configuration of the wave attenuation device and the rubble mount breakwaters. This is not the case for typical segmented breakwaters.

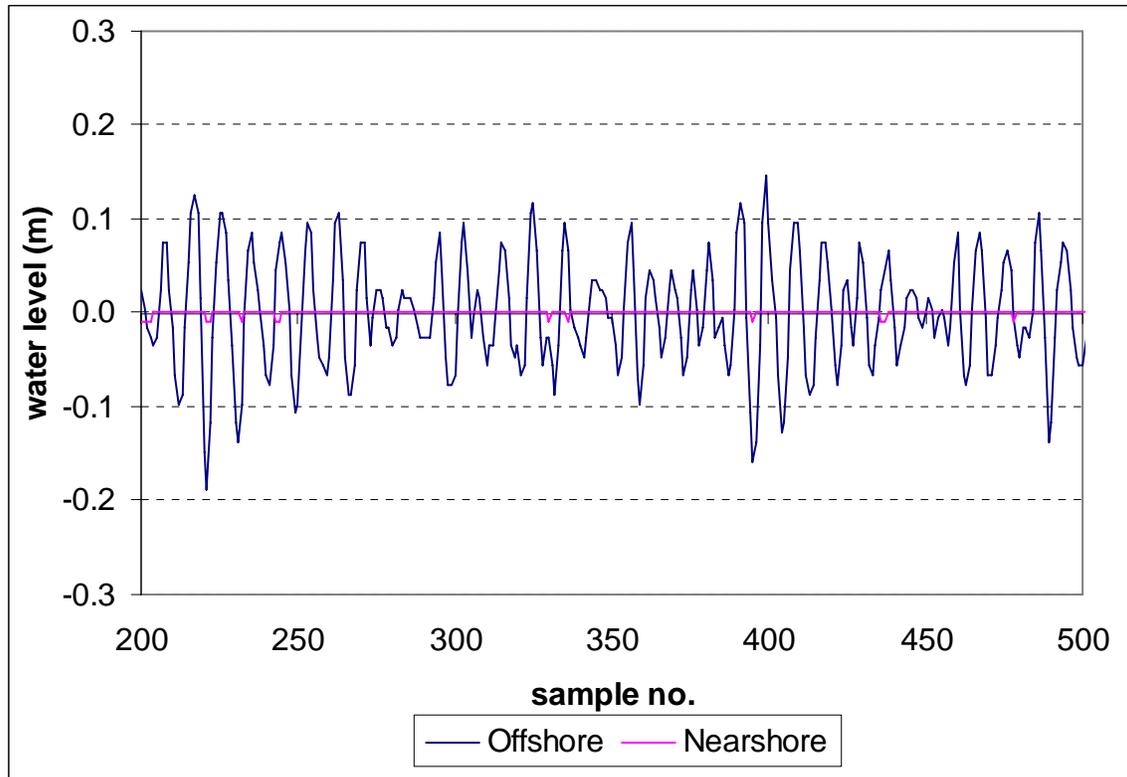
Figure 9. A portion of water level records comparing the offshore condition and condition at site 4, at 17:30.

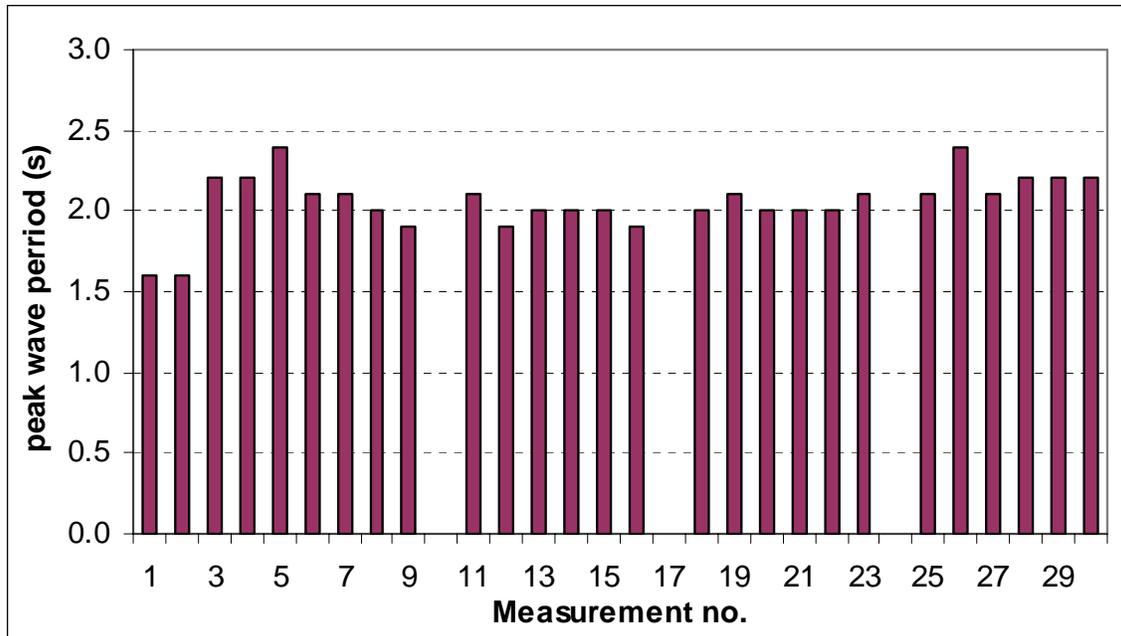
Figure 10. Summary of the measured peak wave period at the offshore site.

Figure 10 summarizes the peak wave period measured at the offshore wave gage during the entire experiment. Overall, the peak wave period remained largely similar, ranging from 1.6 to 2.4 seconds. The short wave periods during the first two measurements and the subsequent increase represent the wave growth and saturation as the sea breeze strengthening throughout the afternoon. Over most of the afternoon, the wave period remained at approximately 2 seconds. Wave periods measured at site 1 are similar to those measured at the offshore gage.

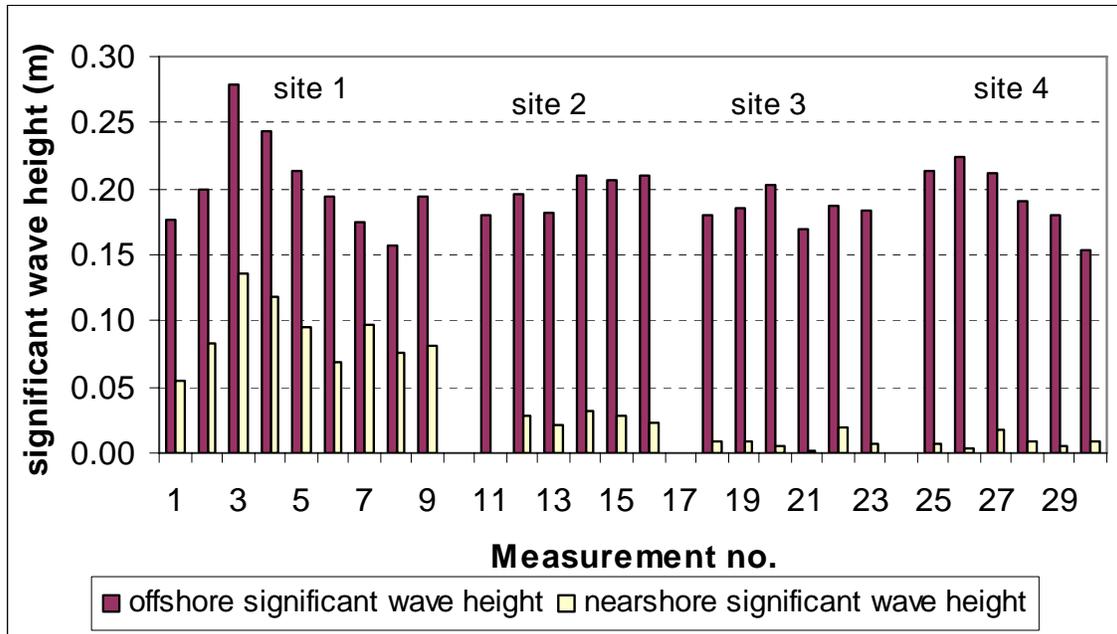
Figure 11. Summary of the measured significant wave heights at the offshore and nearshore sites.

Figure 11 compares the measured significant wave height at the offshore and nearshore sites. Except at site 1, dramatic wave height reduction was measured at all the protected sites, similar to that observed visually. Although this particular wave reduction pattern is a direct result of the specific structural configuration, Figure 11 demonstrates that the wave attenuation device is capable of reducing wave height by nearly 100%. For this specific case, the top of the wave attenuation device was exposed and the incident waves were locally wind-generated high frequency choppy waves.

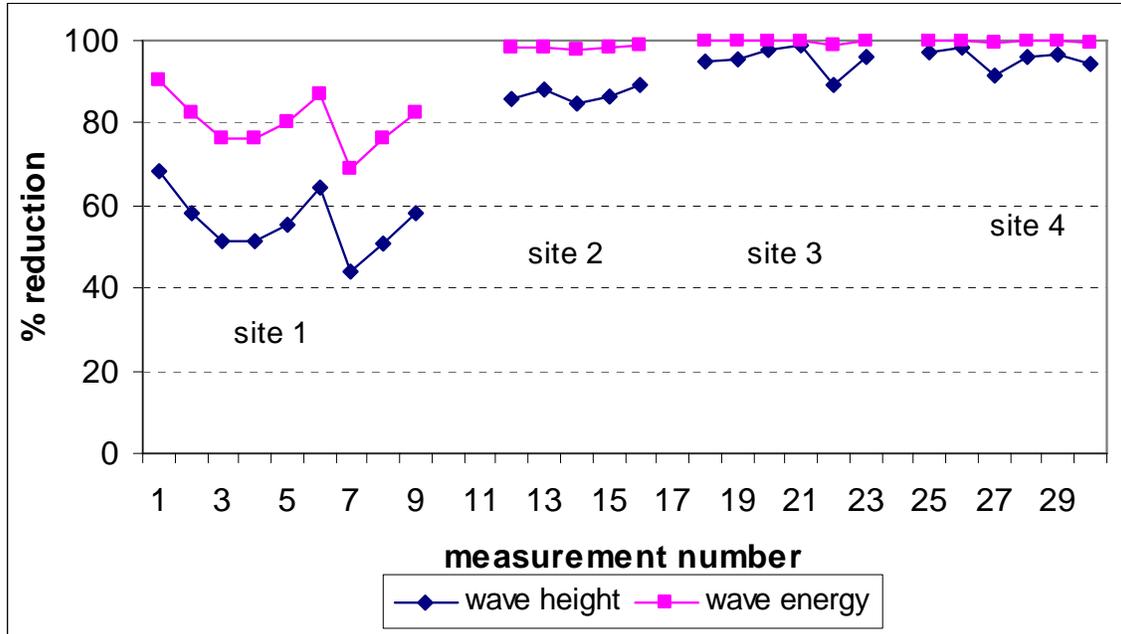
Figure 12. Summary of the percentage wave-height and wave-energy reduction.

Figure 12 summarizes the percentage reduction of significant wave height and wave energy. For nearly all the measurements at the four sites, the wave height was reduced by more than 50% and wave energy was reduced by more than 80%. The relatively less wave-height and wave-energy reduction at site 1 is caused by wave transmission through a substantial gap plus reflected wave from the vertical seawall. Three of the four sites in the protected area showed over 80% wave-height reduction and nearly 100% wave energy reduction for the particular structure configuration and incident wave conditions.
